STAGE II MOTORBIKE TEST

69-011

This document reports the MRDC/ARPA and Border Patrol Police efforts in the Stage II motorbike user evaluation test to determine the appropriate two-wheeled vehicle for use by the latter organization. It presents the background, environment, and test plan, and describes the user evaluation and results therefrom. Motorbike characteristics, noise level test data, and maintenance and logistics data are contained in appendixes to the report. The Honda CT-90 motorbike was found to be acceptable for use by the Border Patrol Police to increase its rural security efforts.

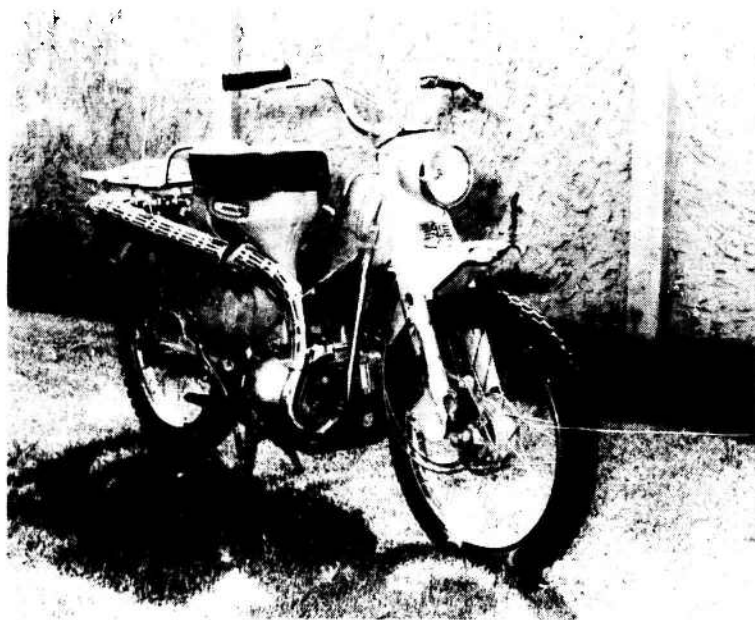
Fig. 1 Honda CT-90 Motorbike, Mountain Type

The primary candidate vehicle selected for the Stage II user evaluation test was the Honda CT-90 Mountain Type Motorbike (Figure 1). In order to provide adequate transportation for a platoon-size unit, a total of 20 Honda motorbikes were purchased by ARPA RDC-T. For purposes of comparison, a second candidate vehicle, the Trailbreaker Motorbike (Figure 2), was included in the Stage II user evaluation test; the choice of this particular vehicle was a result of the USOM Public Safety Division's continued interest in a motorcycle with rough-trail and cross-country capabilities, and the promise shown by this vehicle in the Stage I test. (See Appendix A, for detailed descriptions of the candidate vehicles.)

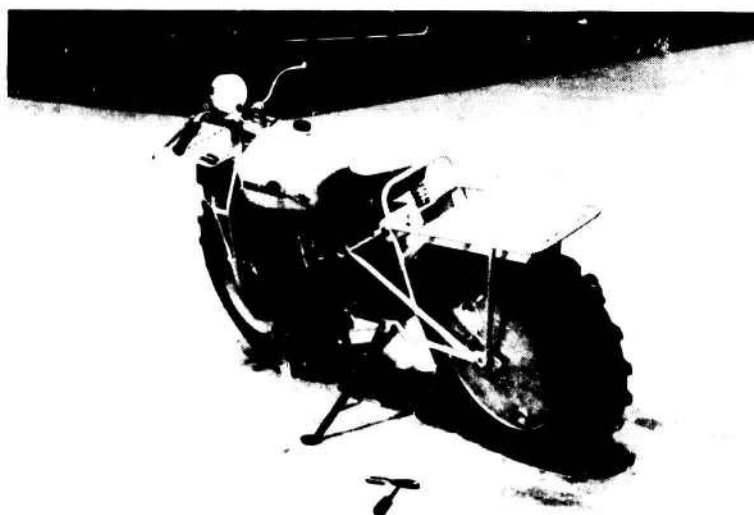
Fig. 2 Trailbreaker Motorcycle

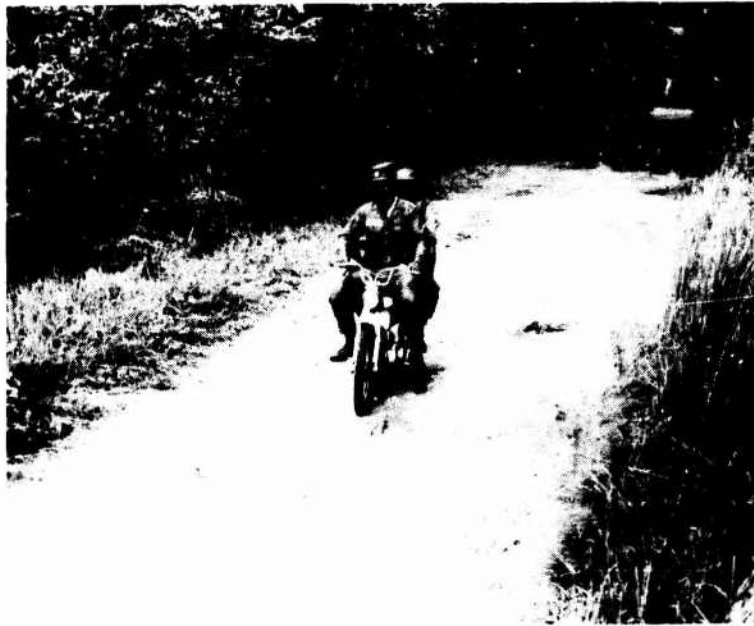
Fig. 11 BPP Motorbike Patrol - Forward Security

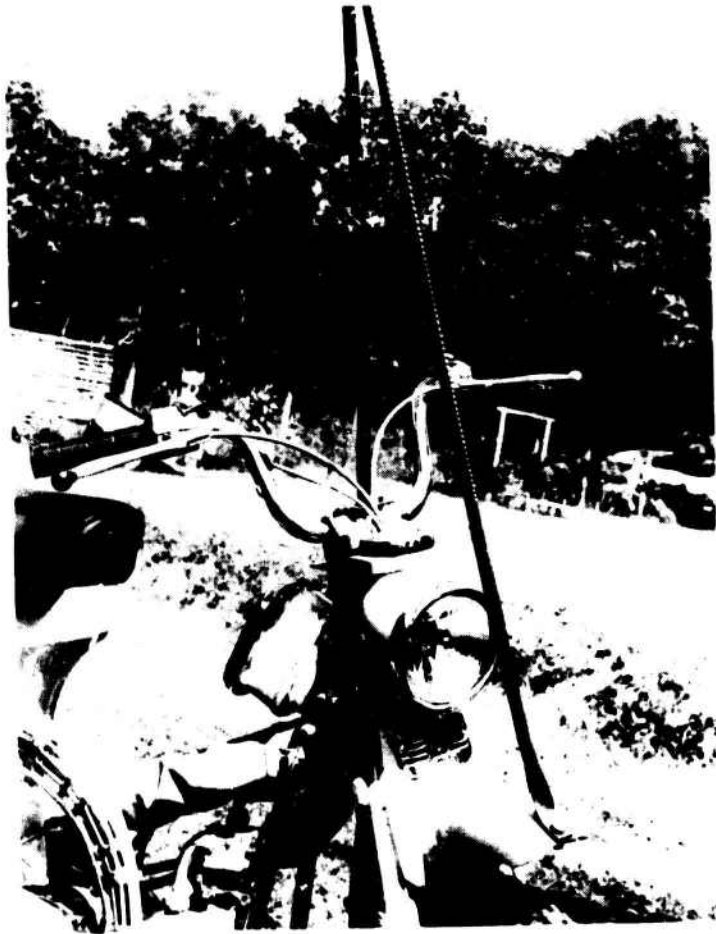
Fig. C-4 Wirecutter Ambush Guard on Honda CT-90

เครื่องป้องกันผู้ขับขี่ตามที่แสดงไว้ในภาพ ซี - 4 ควรพิจารณาติดตั้งบนรถจักรยานยนต์จำนวนหนึ่ง ความมุ่งหมายของเครื่องป้องกันนี้เพื่อป้องกันผู้ขับขี่โดยตัดลดหรือเชือกที่ข้าศึกชิงกันไว้บนเส้นทาง.
